Broken Screw Removal Protocol

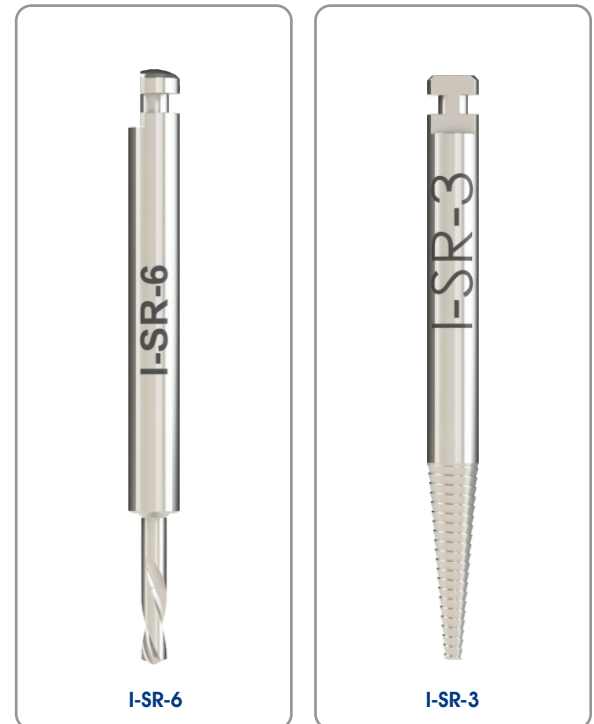
DRILLS

The screw removal drills rotate in a counter-clockwise direction. The first drill, (I-SR-6), cuts a pilot hole in the center of the screw to be removed.

Once the pilot hole has been cut by the I-SR-6, the I-SR-3 is designed to wedge into and engage the internal walls of the pilot hole, and rotate the fractured screw out in a counter-clockwise direction.

600 – 800 rpm for the I-SR-6 with copious irrigation, and 10 - 20 rpm for the I-SR-3.

It is quite possible that this drilling process may thread the screw out the implant, if the drill grips sufficiently while cutting a pilot hole. Note that if the carbon steel tip of the I-SR-6 breaks off inside the implant, it is possible that the implant will need to be removed. If the I-SR-6 does not remove the screw, the next drill, I-SR-3 will be used.
